Diagnosing the Problem: “The Twist”

PCB Stabilization

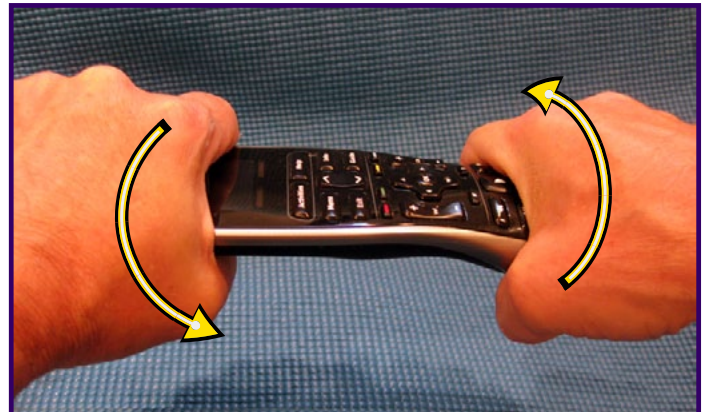
- Remove the battery, wait 30 seconds and insert the battery. Then, very quickly, before the remote has time to start the boot-sequence, gently twist it (like you were wringing out a towel), **hold it in this position** and watch to see if the LCD goes on and the Logitech splash screen appears.
- To do the ‘twist’, hold the remote in front of you in a horizontal position (like it was lying down) and twist the front of the remote towards you and the back of the remote away from you. **The twist should be done gently but firmly and you should hold the remote in this position for at least 30 seconds** or until the main Activity menu appears. If there is no change in the behavior, try the same thing again but twist in the opposite direction.

If the ‘twist’ results in a change of behavior, it usually is an indication of these faulty joints, most commonly underneath the processor (CPU), which is the largest chip on the board. Although this condition can sometimes be repaired by re-flowing the solder underneath the chip, this procedure is difficult, not always successful and generally not cost-effective to do.

There is a procedure that we have had some success with here, that you can try at home. Since the PCB appears to operate normally when slightly bent (which is what the ‘twist’ is doing), a shim placed at the point where pressure can be continuously applied when the back cover is installed seems to do the trick. **We don’t know the longevity of this fix and it does not work on every 900 that exhibits these symptoms**, but it may be worth a shot if it extends the life of your Harmony 900.

Here in the shop, we use a polycarbonate shim about ½” square and 3/16” thick and we more-or-less center it on the top of the CPU. This is the largest IC on the PCB (near the top left with the component-side of the board facing up). Sometimes, the position of this shim must be adjusted slightly left or right or top/bottom in order to change the behavior of the 900. In some instances, a larger shim (not thicker) is required and some of the back cover bridging needs to be removed.
